Title: Production Facility Prototype Blower 1000 Hour Test Results V

Production Facility Prototype Blower 1000 Hour Test Results V

8/16/2021

Alexander Wass, David Dogruel, Keith Woloshun

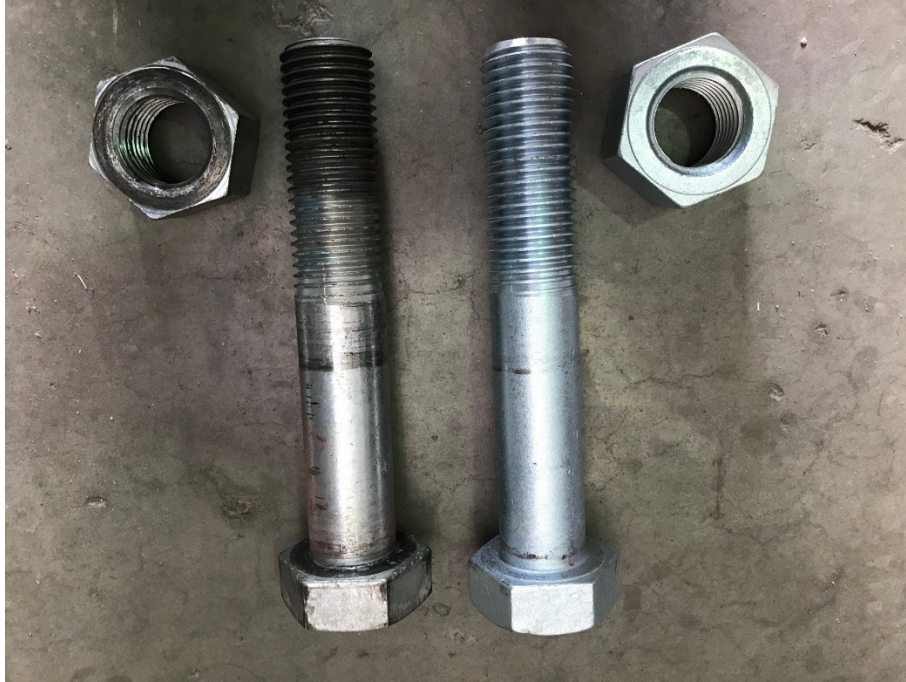
Figure 1 – Old vs. new fasteners

From the start of the long duration test, the helium leak rate was abnormally high (approximately one helium cylinder per day). Therefore, after the first two weeks of operation, the blower was turned off to diagnose the leak. There were two causes of the leak. The first was the pressure relief valve (PRV) that had a slow leak. The PRV leak was fixed by pushing and pulling on the test ring, which re-seated the valve. The other cause of the leak was due to the pressure vessel fasteners and gasket. The gasket was cut undersized by the vendor, which did not create an acceptable seal, and the fasteners had galled over time during the more than thirteen installation cycles. The galled fasteners made it difficult to install and thus, proper torque values were questionable. Therefore, both the gasket and fasteners were replaced with new components. This includes all nuts, bolts, and washers. Figure 1 shows the galled fasteners compared to the new fasteners. Once closed and filled with helium, the leak rate was as expected.

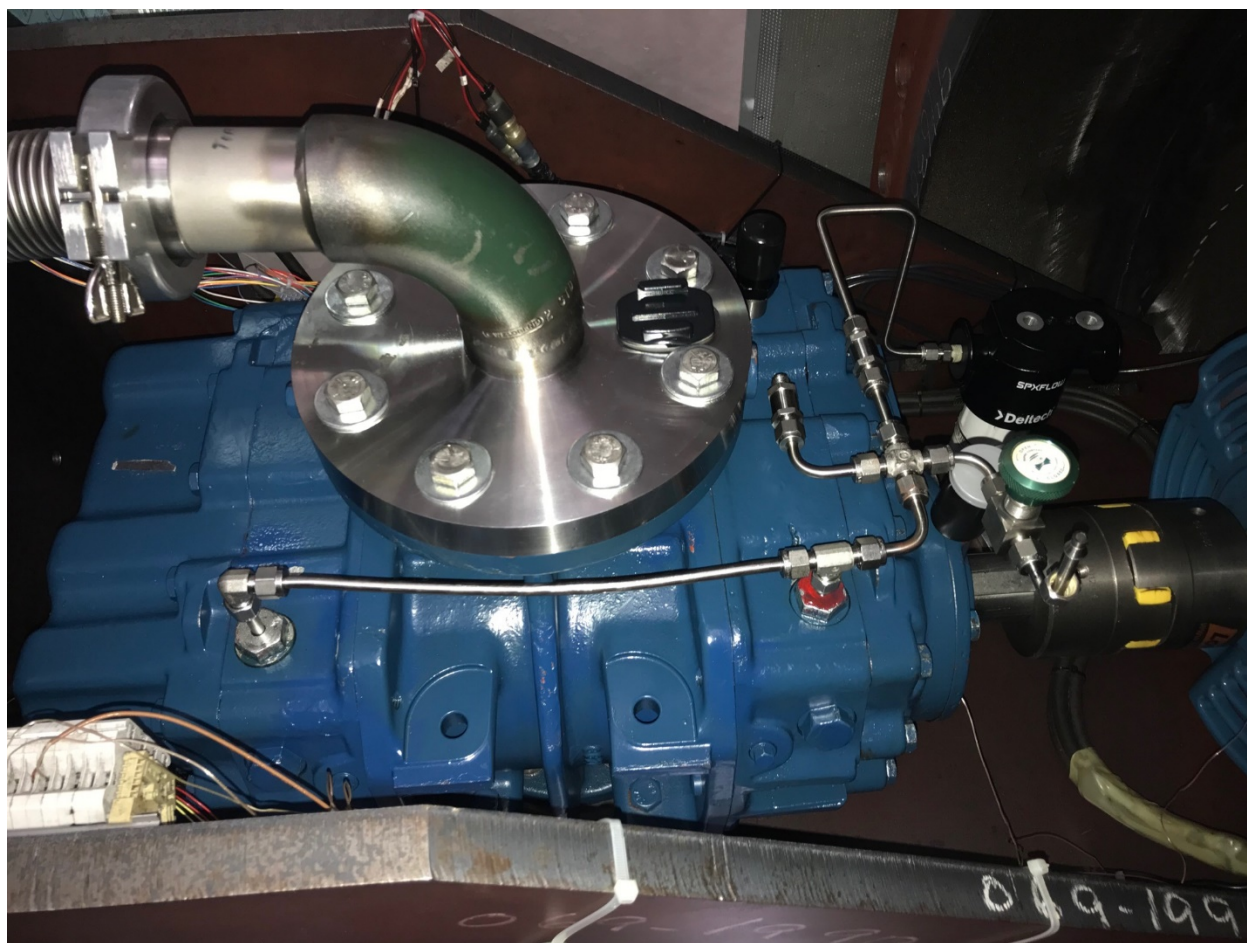
Figure 4 – Oil-free blower surface after thirteenth test

Upon completion of this test, the pressure vessel was depressurized and opened to determine if the internal camera and RGA results were consistent. No oil leaks were found during this test. The blower surfaces can be seen in Fig. 4. Figure 5 shows the oil levels at the rear and shaft-side gear boxes. The shaft-side gear box was dark due to grease leaking into the oil. At the beginning of this test, grease was pumped into the shaft side bearing to make up for losses during the previous test, however, too much grease was added and leaked into the oil, causing the discoloration.

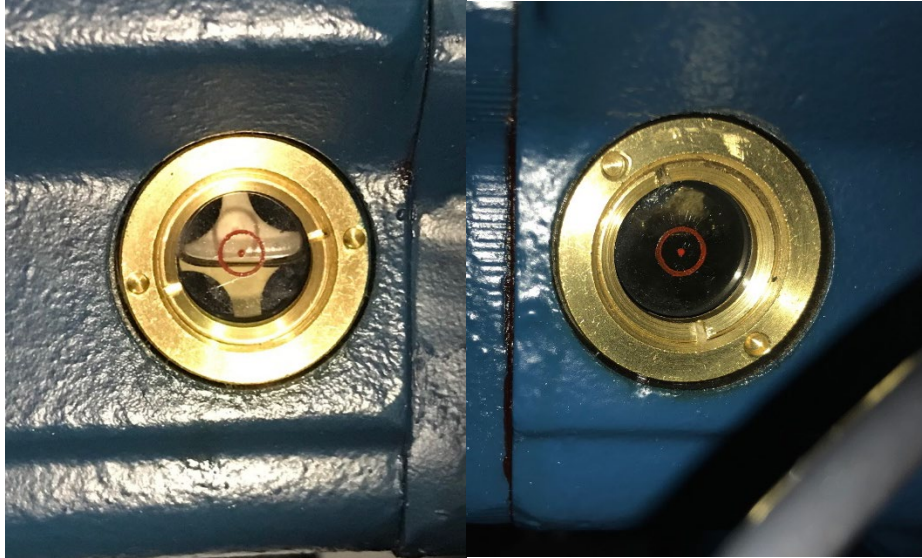
Figure 5 – Non-shaft side gearbox oil level (left) and shaft side oil level (right)
